GEND-INF- 074

TMI-2 CORE CAVITY SIDES AND FLOOR EXAMINATIONS

DECEMBER 1985 AND JANUARY 1986

M. L. Russell

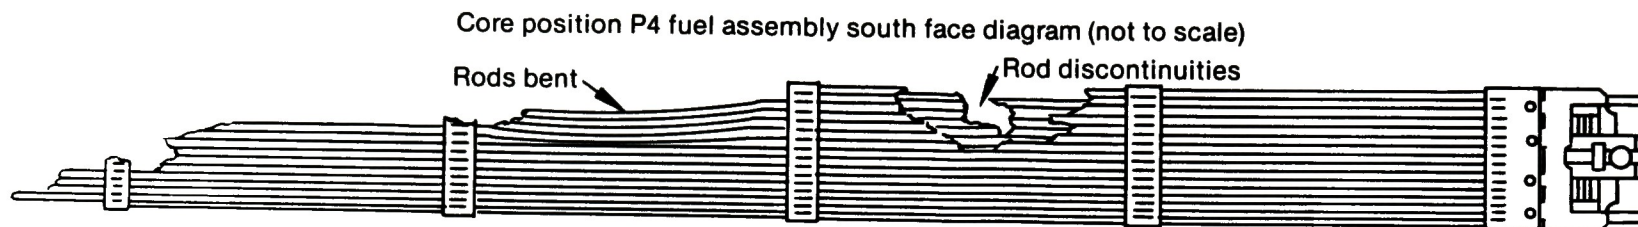
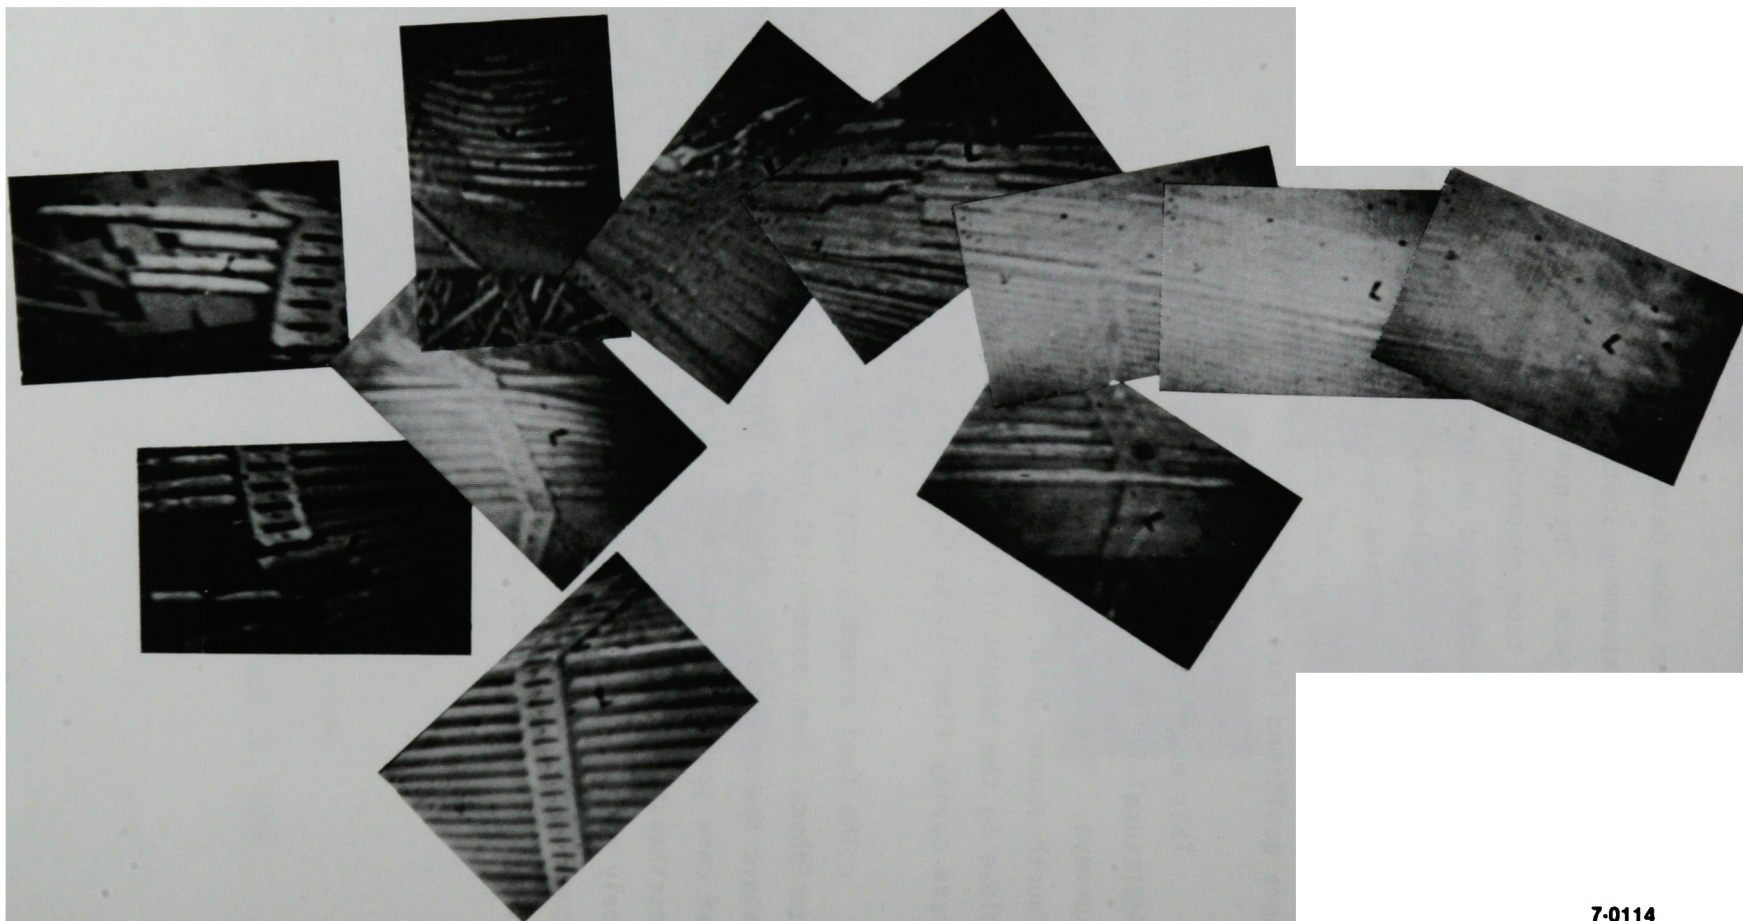
This examination is of special interest because approximately an additional 40 in. of fuel assembly is exposed compared to the December 1985 surveys. The fuel assembly damage appears to increase significantly at the fourth spacer grid, which is approximately 70 in. above the core bottom and close to the height of the hard crust that has been encountered below the core cavity floor loose debris.

The fuel assembly upper region damage is consistent with other peripheral fuel assemblies including the bow on the rod bundle that exists above spacer grid 5. The rod bundle bowing appears to have occurred also at core south (Plates 5 and 10), southeast (Plate 6), east (Plate 7), and northeast (Plate 8) locations. Because the bow appears to occur between only one set of spacer grids, it may be an artifact of fuel assembly buckling from differential thermal expansion between the fuel assembly and the core support structures during the core heatup.

Plate 11. TMI-2 core position P4 fuel assembly.

The core peripheral fuel assembly damage appears to increase significantly below the core cavity floor level and especially near the observed height of the hard crust that has been encountered below the core cavity floor loose debris. The observation was derived from the examination of the toppled core position P4 fuel assembly (Plate 11), which has typical peripheral fuel assembly damage in the upper regions.
